ARCHEOLOGICAL INVESTIGATION
OF THE EAST AND WEST BARRACKS
AT FORT FREDERICK STATE PARK,
WASHINGTON COUNTY, MARYLAND

PREPARED BY
Stephen Israel, M.A.

January 1975

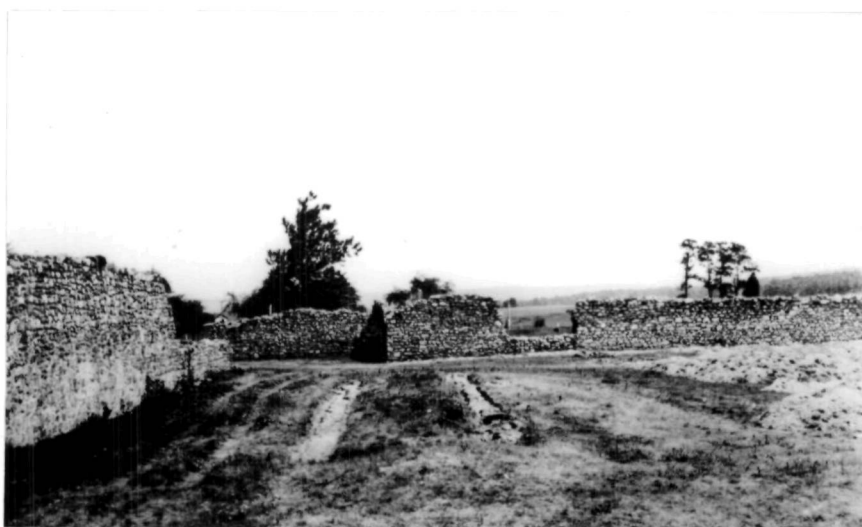
Plate Ia

A view looking NNW. Initial excavation of west barrack foundation. Note unevenness of ground grade. North curtain wall is in background. Photo taken 1933-1934.
Maryland Geological Survey negative #485 A

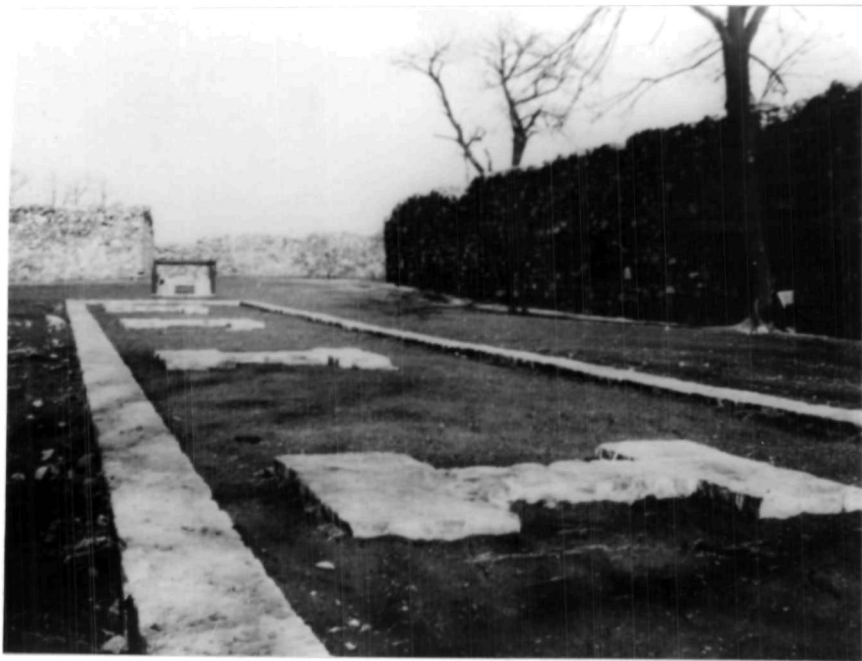
Plate IIIB

A view looking North. Foundation of east barrack brought to new and level grade. NE Bastion, well and east curtain wall are in background. Photo taken 1935-1936. Maryland Geological Survey negative #450A

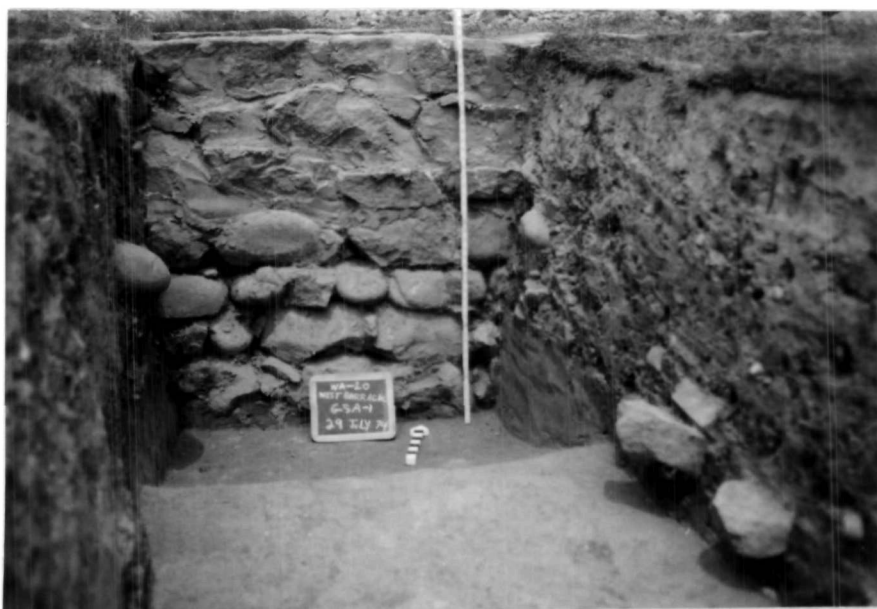
Plate IVa

A view looking North. South Foundation wall of west barrack showing CCC's stone capping on top of the 1756 stone foundation. Note, 30 inch deep lenses of CCC raised fill. The 1756 foundation is distinguished by its soft, sand, lime, and earth matrix mortar and natural round stone.

Trenches A, B, C, D, and Backhoe Trenches A-1 through 12 revealed a fill 15 to 30 inches deep (Figs. 2, 3, & 4; Plate IVa). On the exterior of the long sides of the barrack, the top soil and underlying yellow, orange, and brown gravelly clay and red gravelly clay lenses cover a brown sandy loam and shale lens. The latter soil lens and the 1756 stone foundation denote contemporaneity, for the lens abutts the stone wall and its high organic content typifies an occupation lens. Scattered cultural refuse was recovered in this brown sandy loam and shale lens (Table III). Beneath the above disturbed and fill soil lenses lies an undisturbed beige-tan sandy clay subsoil.

and the completely rebuilt north foundation wall (Table II; Plates IVa and IVb). In contrast, the thickness and width of the capping on the east barrack was more uniform.

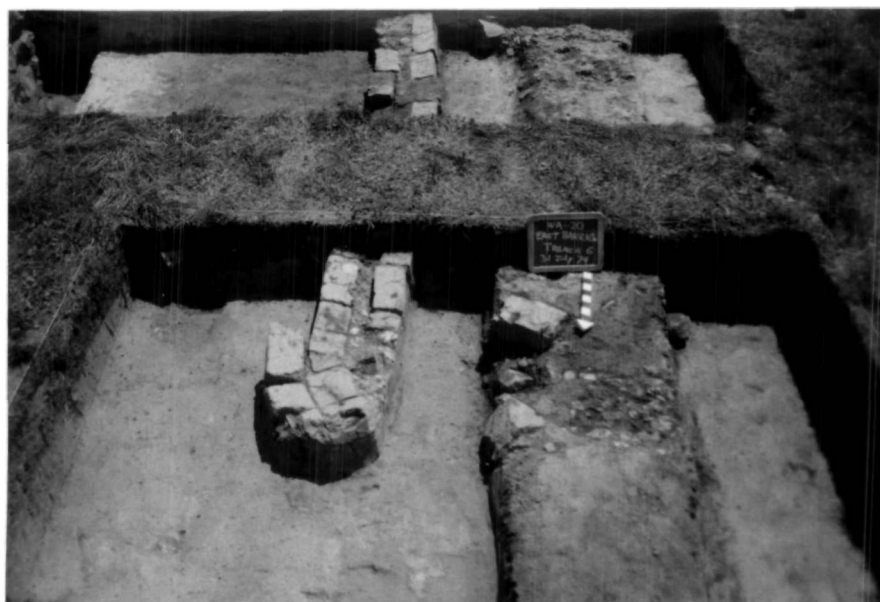
Plate VIa

A view looking south. Elongated insloping brick feature (possible drain). To the left is the west wall of the east barrack. On the right is the backfill of a CCC trench.

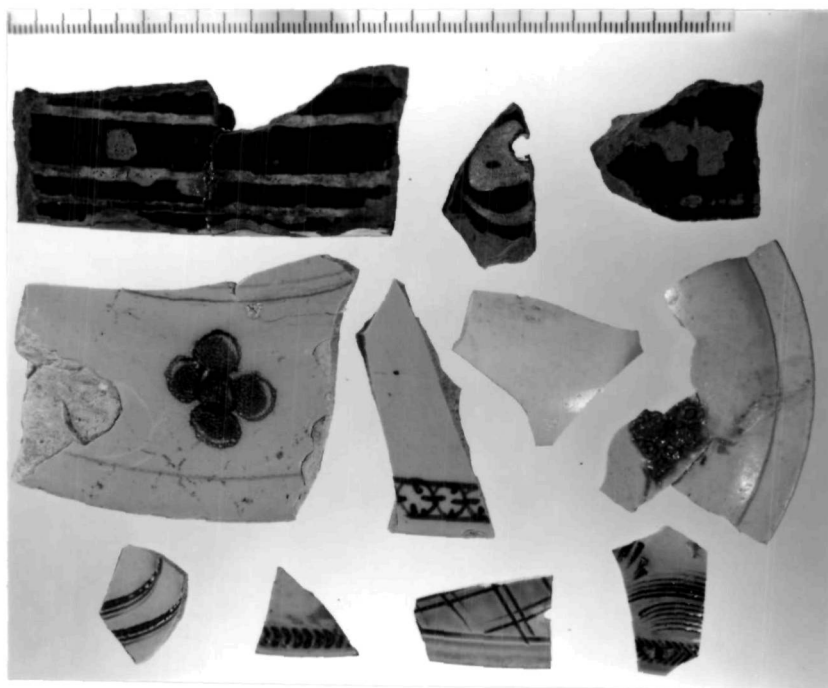
Plate VIII

EAST AND WEST BARRACK CERAMIC ARTIFACTS:

Top Row: Scratch Blue Rimsherds, excavated feature ,
black humus lens inside west barrack and occupation lens outside
of west barrack; Middle Row: Saltglaze Bowl Lid sherd, disturbed
black humus and tan clay lens outside west barrack; Creamware
rimsherd, top soil inside west barrack; Delft rimsherds, top
soil inside west barrack and occupation lens outside west
barrack and occupation lens outside west barrack, top soil
inside west barrack and excavated feature.
